**Assessing 15 Redwoods East of
6630 and 6578 Oak Leaf Court
And East of 2000 Oak Circle
In Yountville, CA 94599**

Prepared for:
John Feron, Public Works Director
jferons@yville.com
Yountville, CA

Submitted by Tony Wayne Wolcott Consulting
Registered Consulting Arborist #685
ISA Board Certified Master Arborist WE3284 B
959 Cheyenne Drive,
Walnut Creek, CA, 94598

February 15, 2024

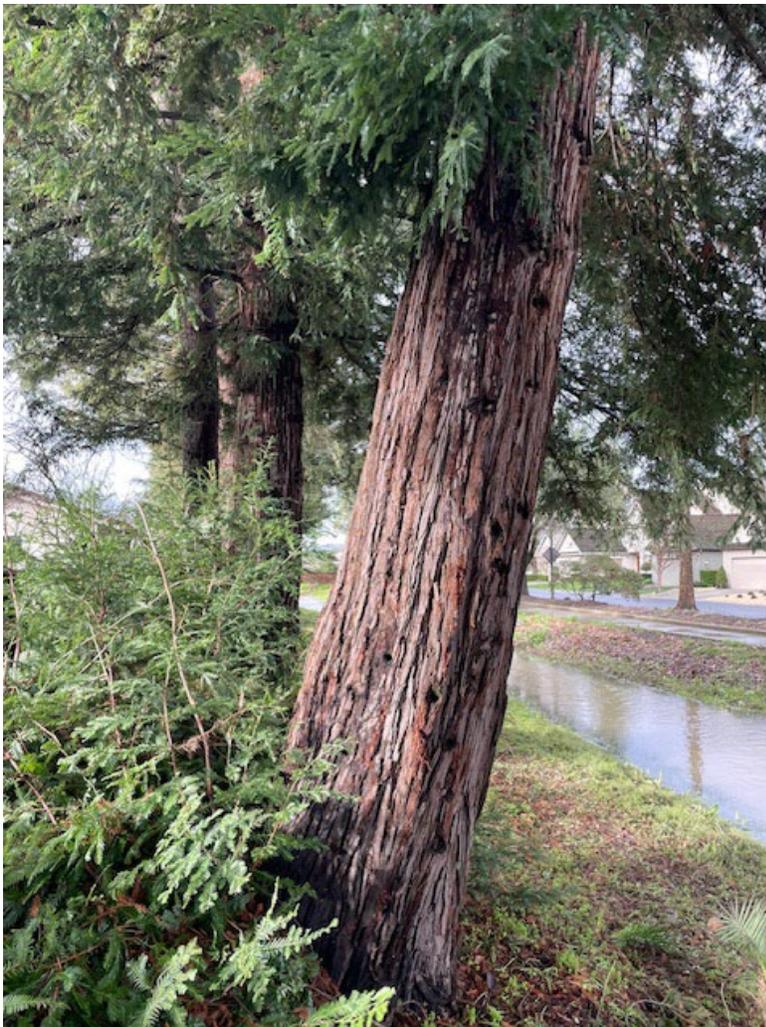
This photo shows Tree #10's trunk but reveals the creek level and the trees on Heather Street.

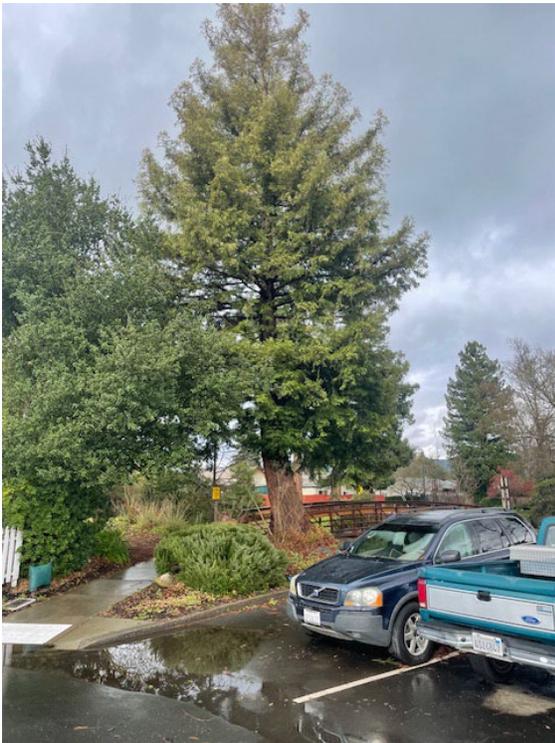
Tree #1 is an excellent tree to use as a comparison. Its structure and health are outstanding.

Trees 1 through 3 are sustainable and low-risk trees. Trees 5, 6, 7, 8, 9, 10, and 15 are also low-risk and sustainable.

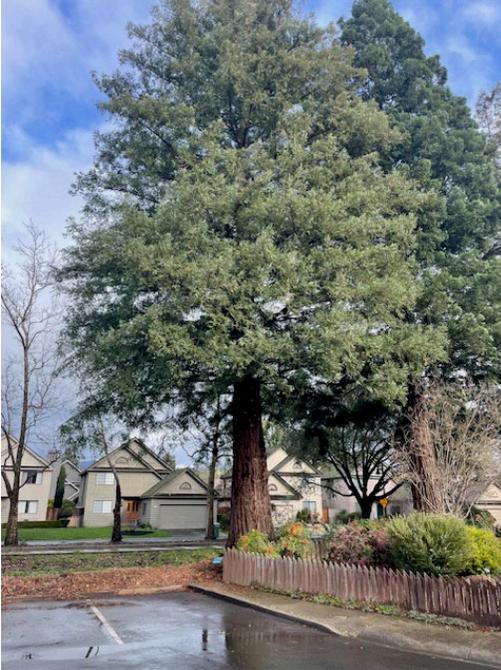
Tree #2 is limbed up 20 feet, with some flat areas on the trunk, and is in good shape overall.

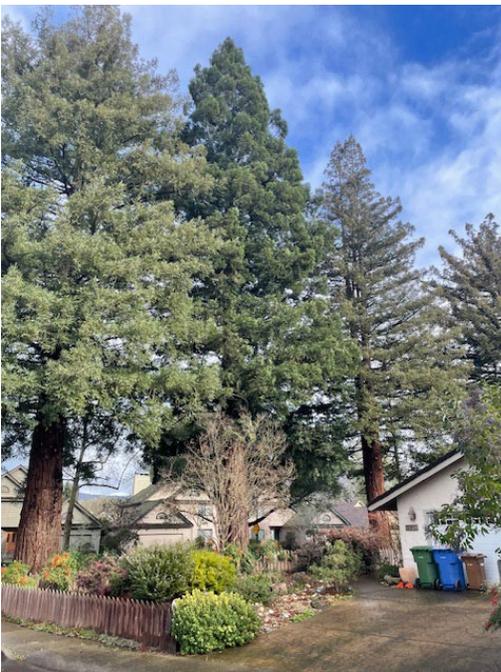
Tree #3 has dark green foliage, an excellent Redwood.

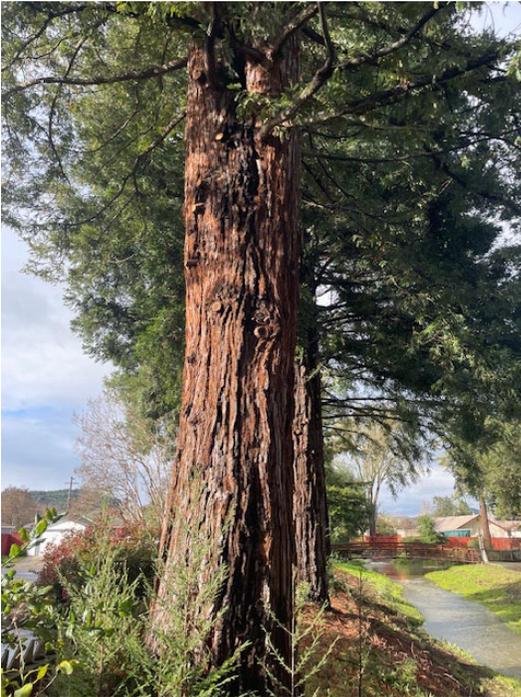
Tree #4 has damaged cambium on the lower trunk and co-dominant stems with included bark. The top has dead branches.

I recommend that Trees #4, 11, 12, 13, and 14 all be removed due to decay, included bark and weakly attached co-dominants.

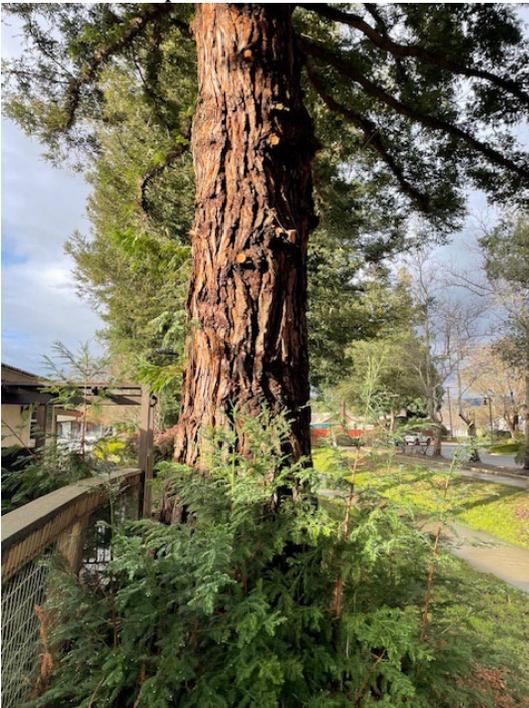
Tree #5 has lost some branches to pruning, wider branches, and is somewhat stunted.

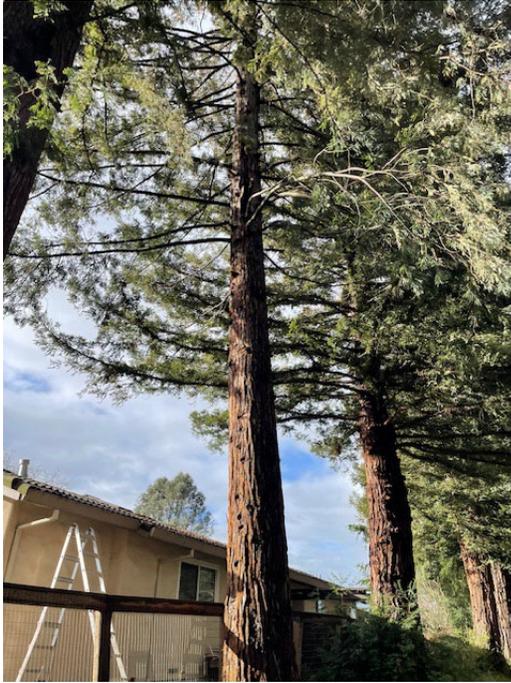
Tree #6 has thin, broken branches, with 30 feet of removed branches, but healthy.

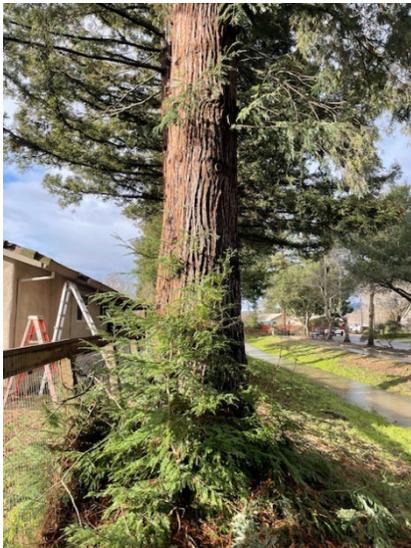
Tree #7 is in good shape; the vertical crack is not in the tree's wood.

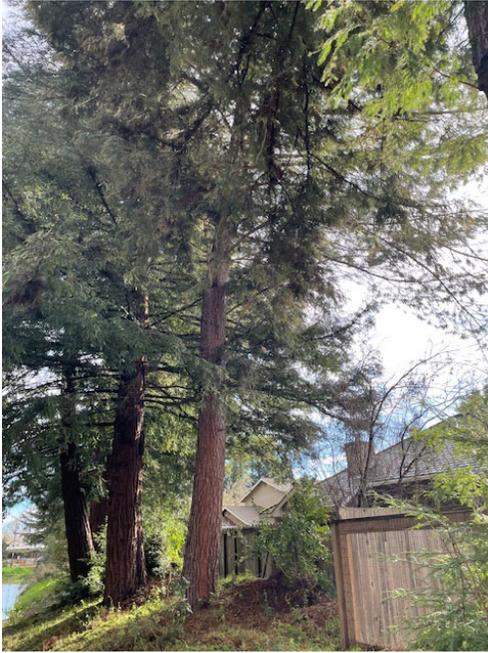
Tree #8 is a Loblolly Pine in fair condition, looking for light.

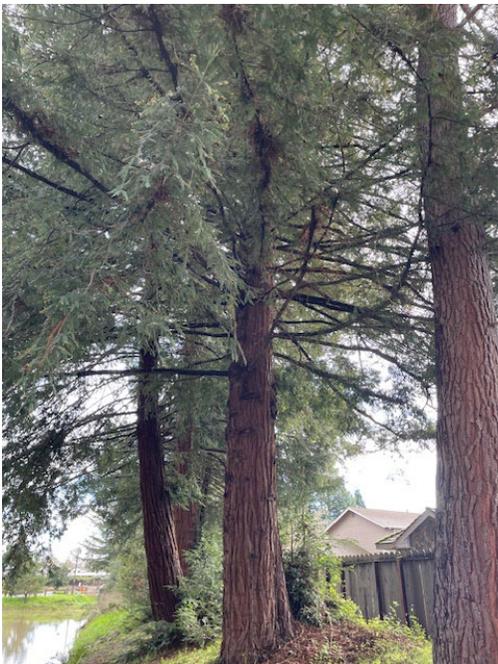
Tree #9 is flat on one side and has some deadwood, but it is a decent tree overall.

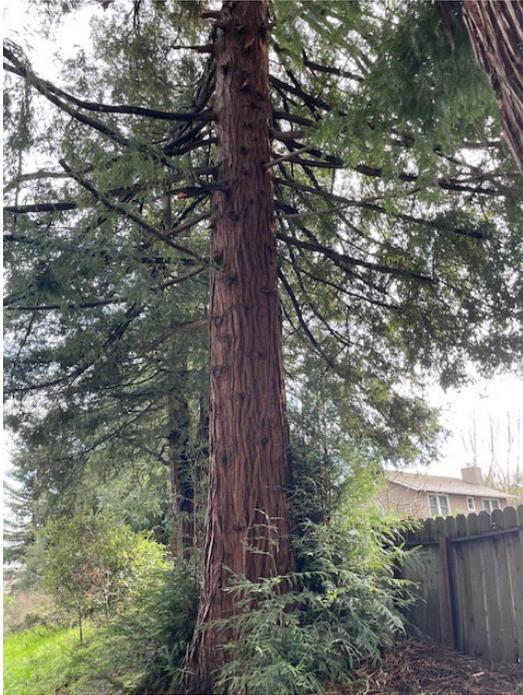
Tree # 10 has a swayed trunk that is corrected, has limited foliage, and is weak.

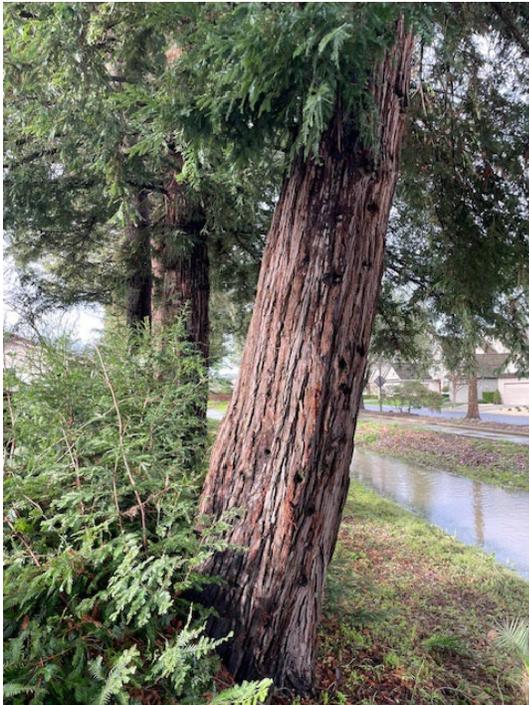
Tree #11 has many cut, over-thinned, and broken branches but is solid.

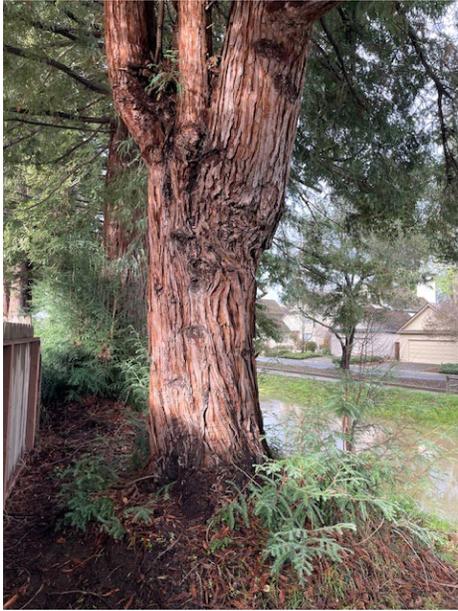
Tree #12 has old topping cuts, multi-stemmed with weak attachments with some decay.

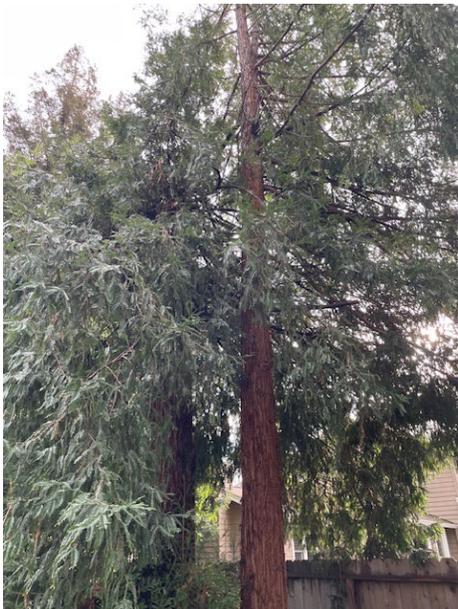
Tree #13 has decayed, lost one stem already, and has decay in roots.

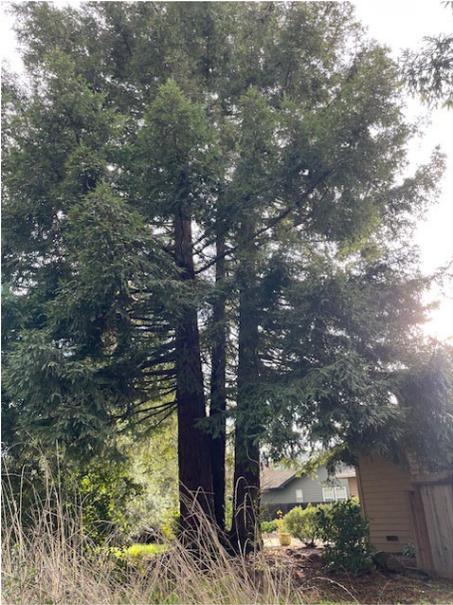
Tree #14 has a poor structure with three competing trunks, healthy foliage, and branches.

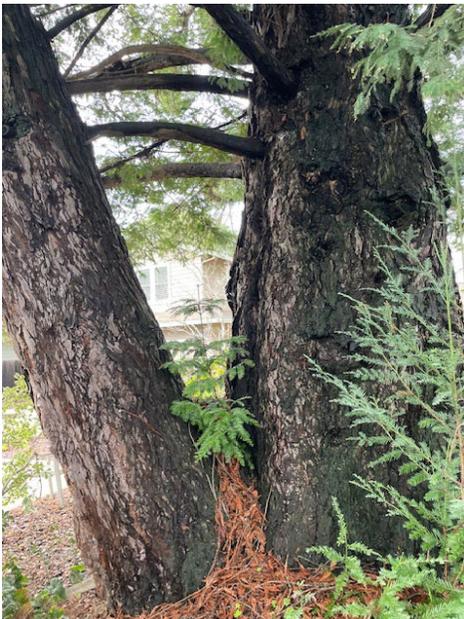
Tree #15 has a massive trunk and is co-dominant, with some branch breaks.
