RE: Arborist Consulting Services for the project: 2010 Humboldt St, APN #036-054-023-000, City of Yountville jurisdiction, CA

Thank you for contacting Focal Point Arboriculture Consulting to evaluate the trees along the street on both Jefferson St and Humboldt St to provide an opinion as to the condition of the trees with respect to their health and structural adequacy to remain on the site during development of the parcel. The property is 2010 Humboldt Street, on the northeast corner of Humboldt and Jefferson Street in Yountville, CA, and is subject to the jurisdiction of the City of Yountville, CA.

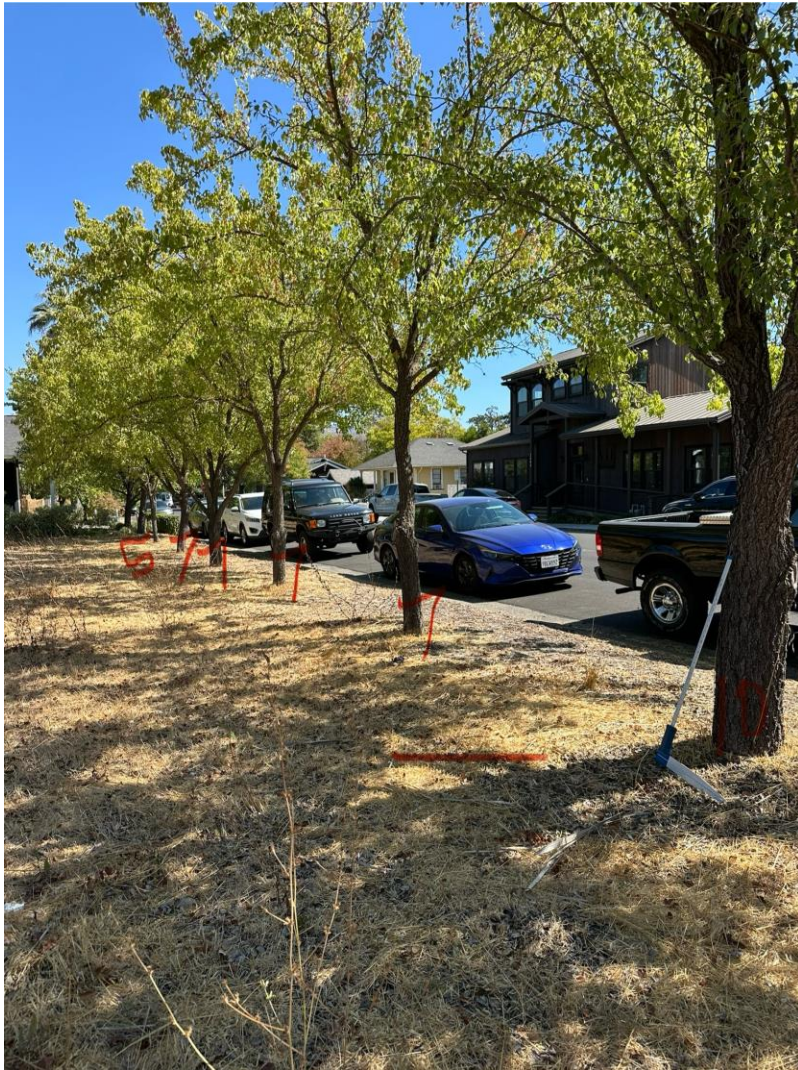
I visited the site on September 24th, 2024, to evaluate the trees and onsite conditions. The majority of the trees are Ornamental Pear, *Pyrus calleryana*, measuring between 5" and 10" diameter¹. They are declining due to lack of care and irrigation. The canopy opacity² on most of the trees is less than 40% but it is noted that many twigs remain and appear to be live. None of these trees have grown to their potential in the current situation despite the length of time they have been there, approximately 18 years (They appear to have been planted in late 2006 or early 2007). This species of tree was widely planted in landscapes and as street trees 40 years ago and can generally be counted on to perform well for 30 to 40 years before structural breaks from the narrow branch structure become predominant and they have to be replaced. The civil plans³ show grade changes right up to the back of the sidewalk, replacement of the sidewalk and curb and gutter. It is my professional opinion that the current condition of these trees combined with the likely root impacts will likely cause the demise of the trees and their remaining lifespan is short.

Photo #1. Trees along Humboldt Street. Opacity appears better in the photo than it actually is.

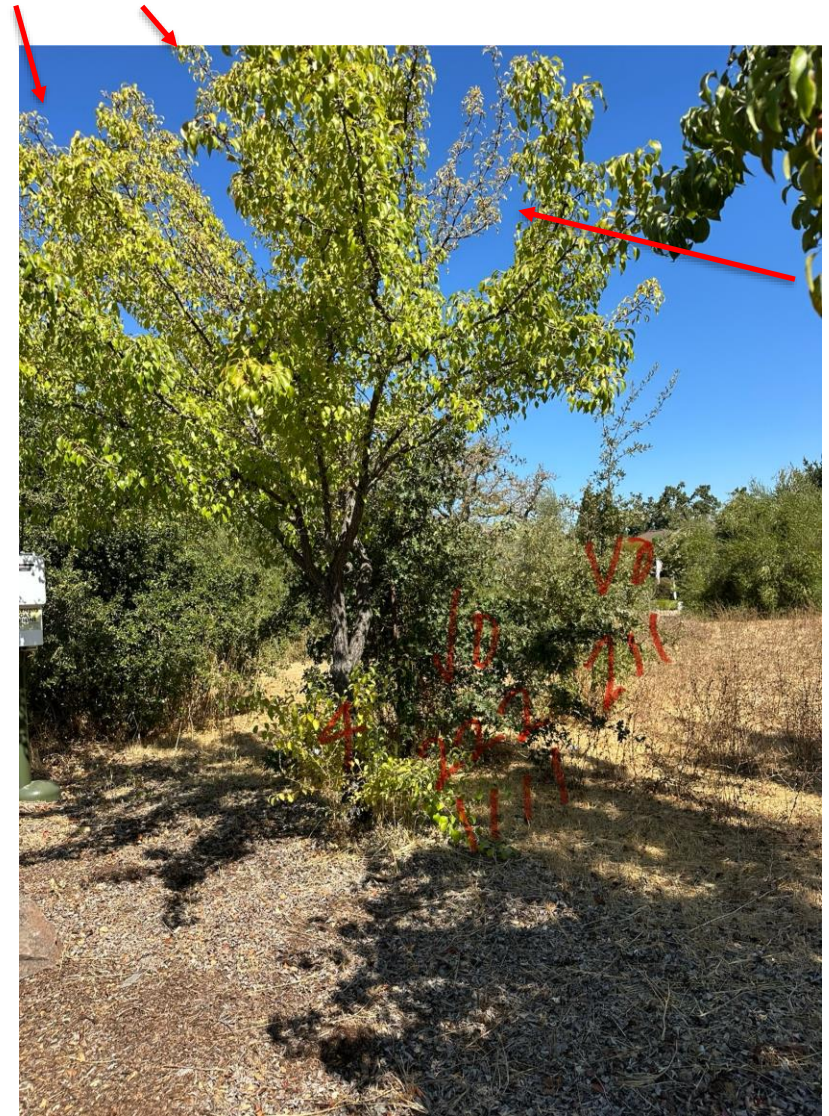
Photo #2. Trees along Jefferson Street. Note branches dying (red arrows)

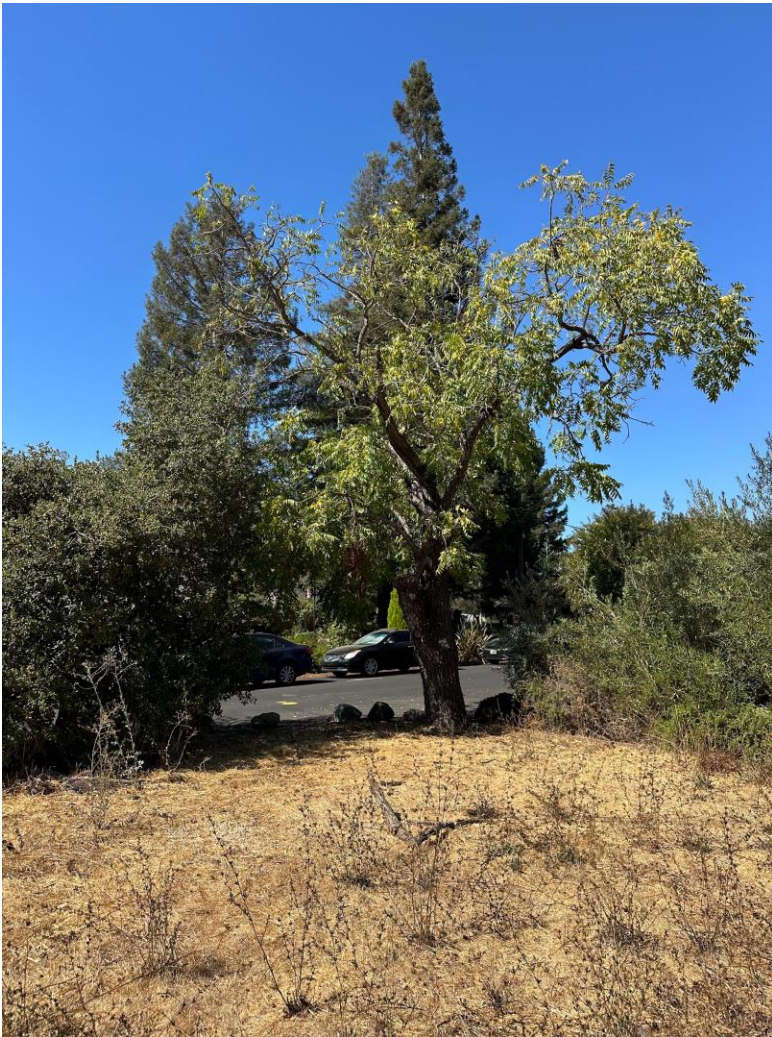
There is a California Black Walnut, *Juglans hindsii*, measuring 24" diameter at the northwest corner of the property. This tree has been in a decline cycle for many years. It has large dead branches and significant decay at the branch junctions. A risk assessment may indicate that an biennial severe pruning could keep the tree in the landscape for longer but it is likely to reduce the lifespan further and result in a tree with a poor aesthetic value. Accordingly, it is also my professional opinion that this tree be removed.

| Tree # | Species Common Name | Species Botanical Name | DBH | At | Arborist Rating | Notes | Reason for Removal |
|---|---|---|---|---|--|--|--|
| 1 | Ca Black Walnut | Juglans hindsii | 24 | 12 | 1-Extreme Structure or Health Problems | Too much dieback and decay | Poor condition of tree. Low lifespan and root protection during development would limit work on the site |

Photo #3. Tree #1, Walnut. Not much canopy looking west.

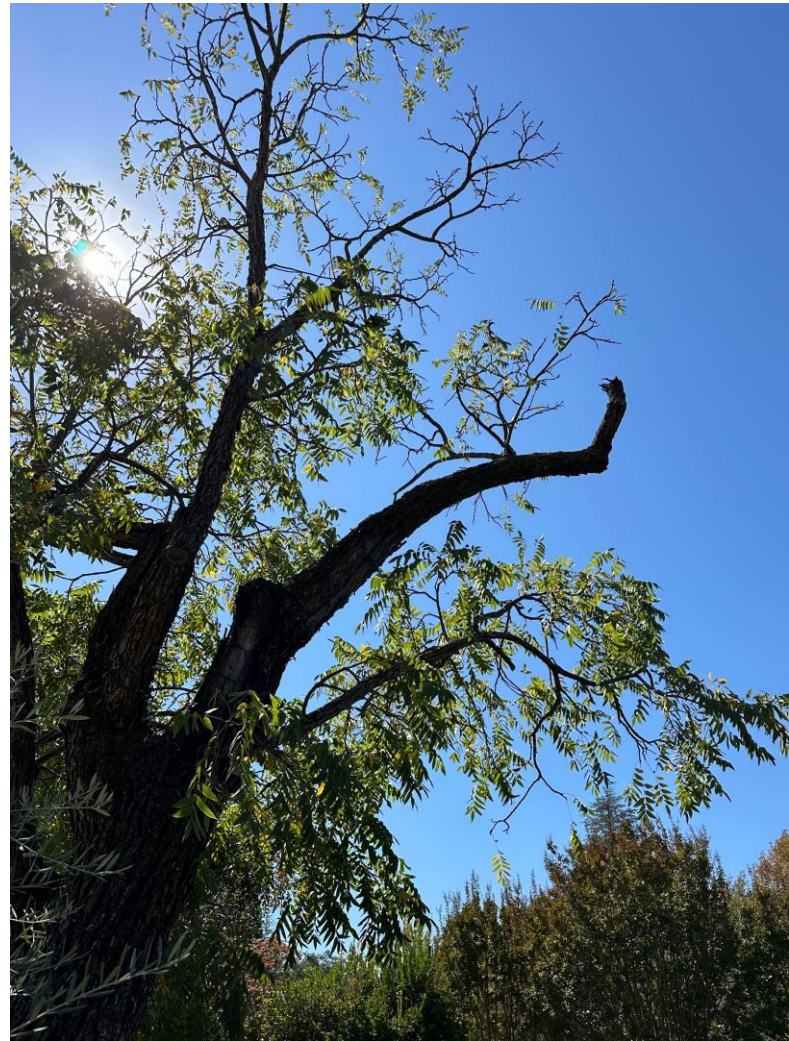
Photo #4. Tree #1, Walnut. Dead branches looking east.

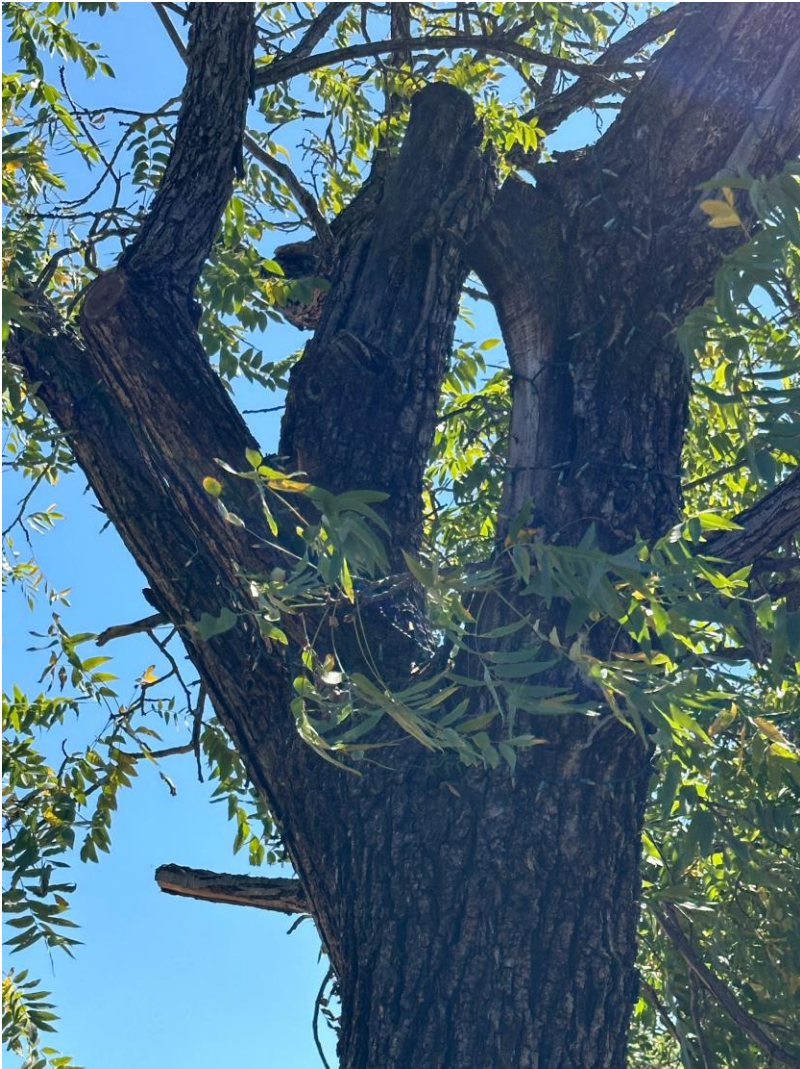
Photo #5. Tree #1, Walnut. Decay at main structural junction.

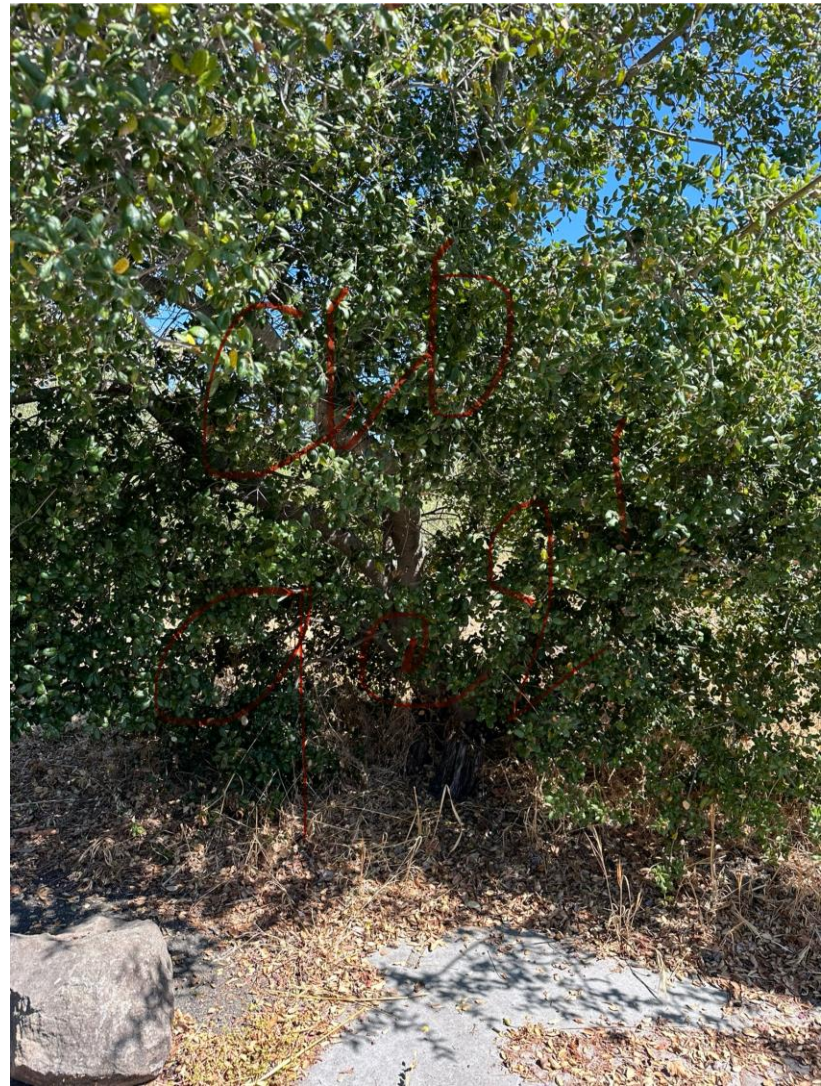
| Tree # | Species Common Name | Species Botanical Name | DBH | At | Arborist Rating | Notes | Reason for Removal |
|---|---|---|---|---|--|--|--|
| 2 | Coast Live Oak | Quercus agrifolia | 9 | 24 | 3-Minor Problems | Shrub structure but could be pruned | Too close to development. Hard to protect during grading/trenching and root protection would limit development |

Photo #6. Tree #2, Coast Live Oak. Shrub form with multi-stem structure from 1'.
